# 2022 CT-Index Test Results for SuperPave Mixes

# 2022 LESSONS LEARNED

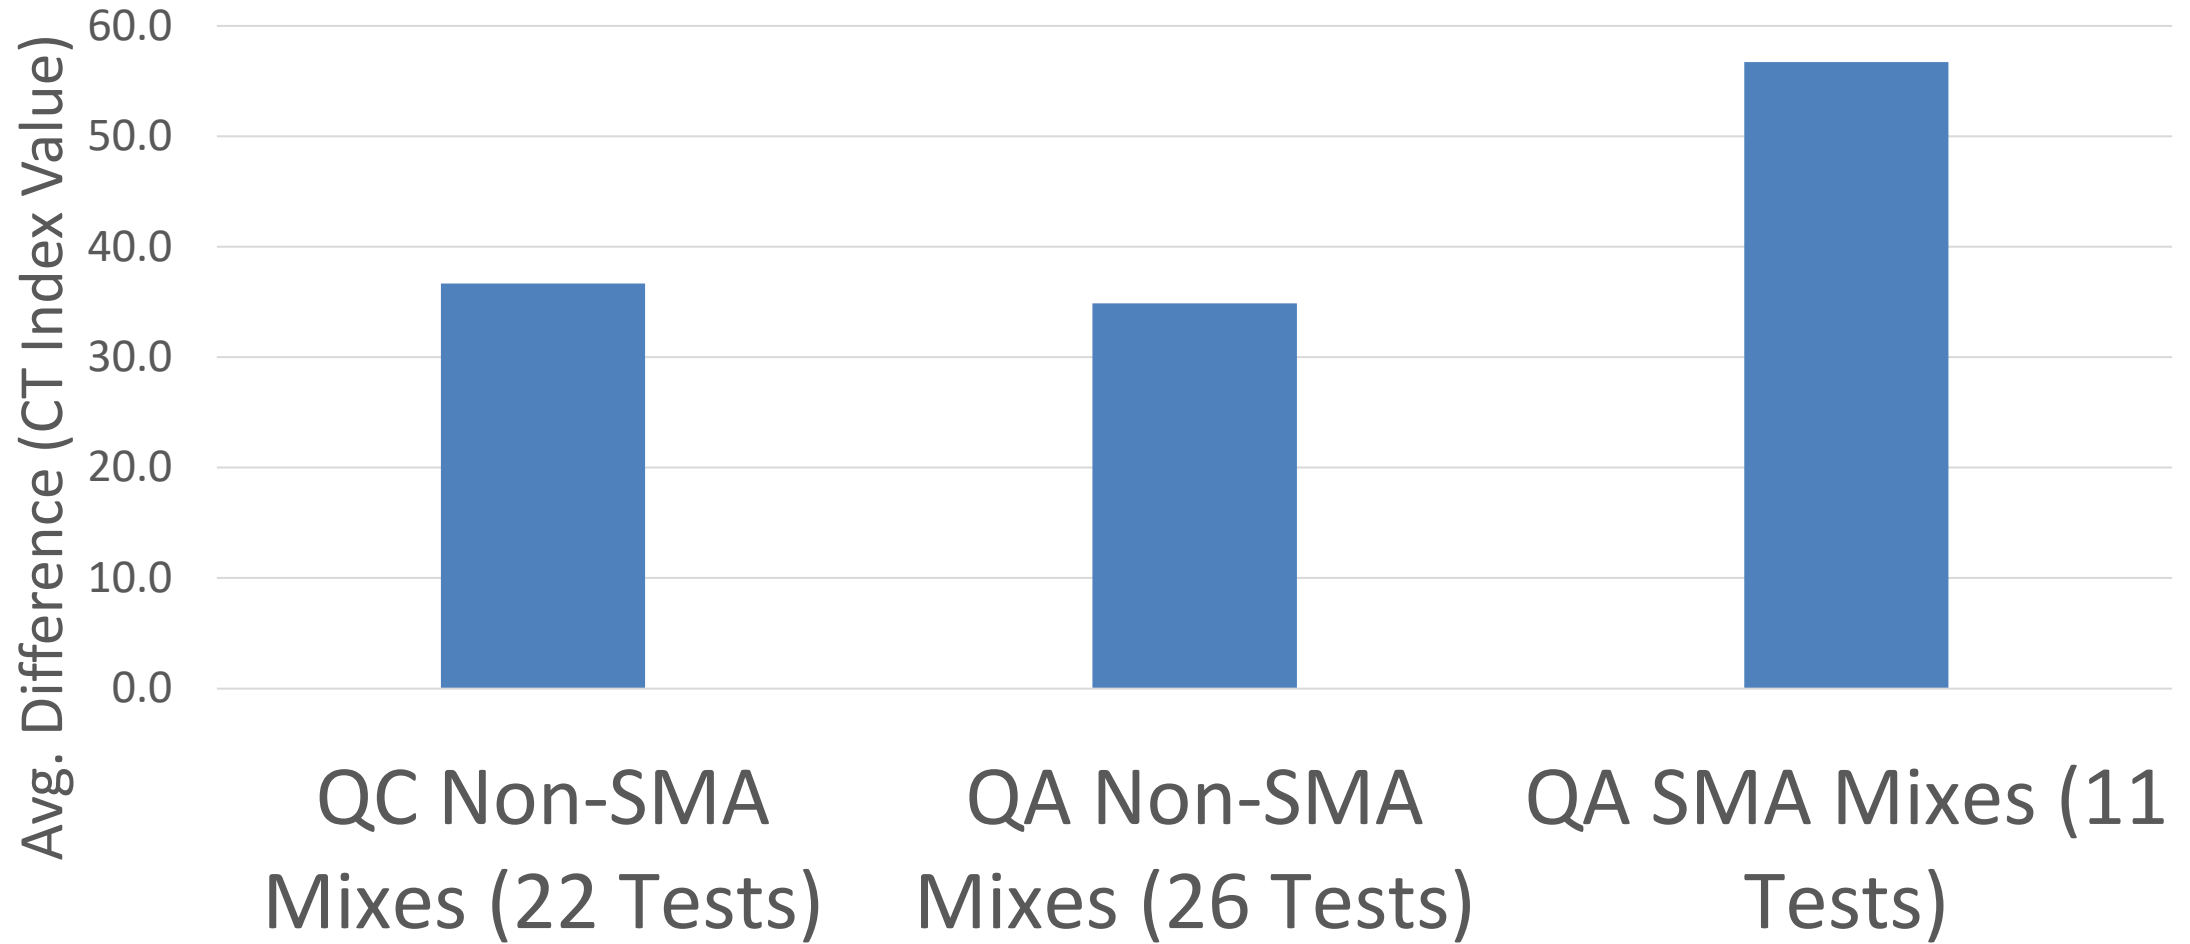
# Avg. Difference of Individual Pucks for 1 test

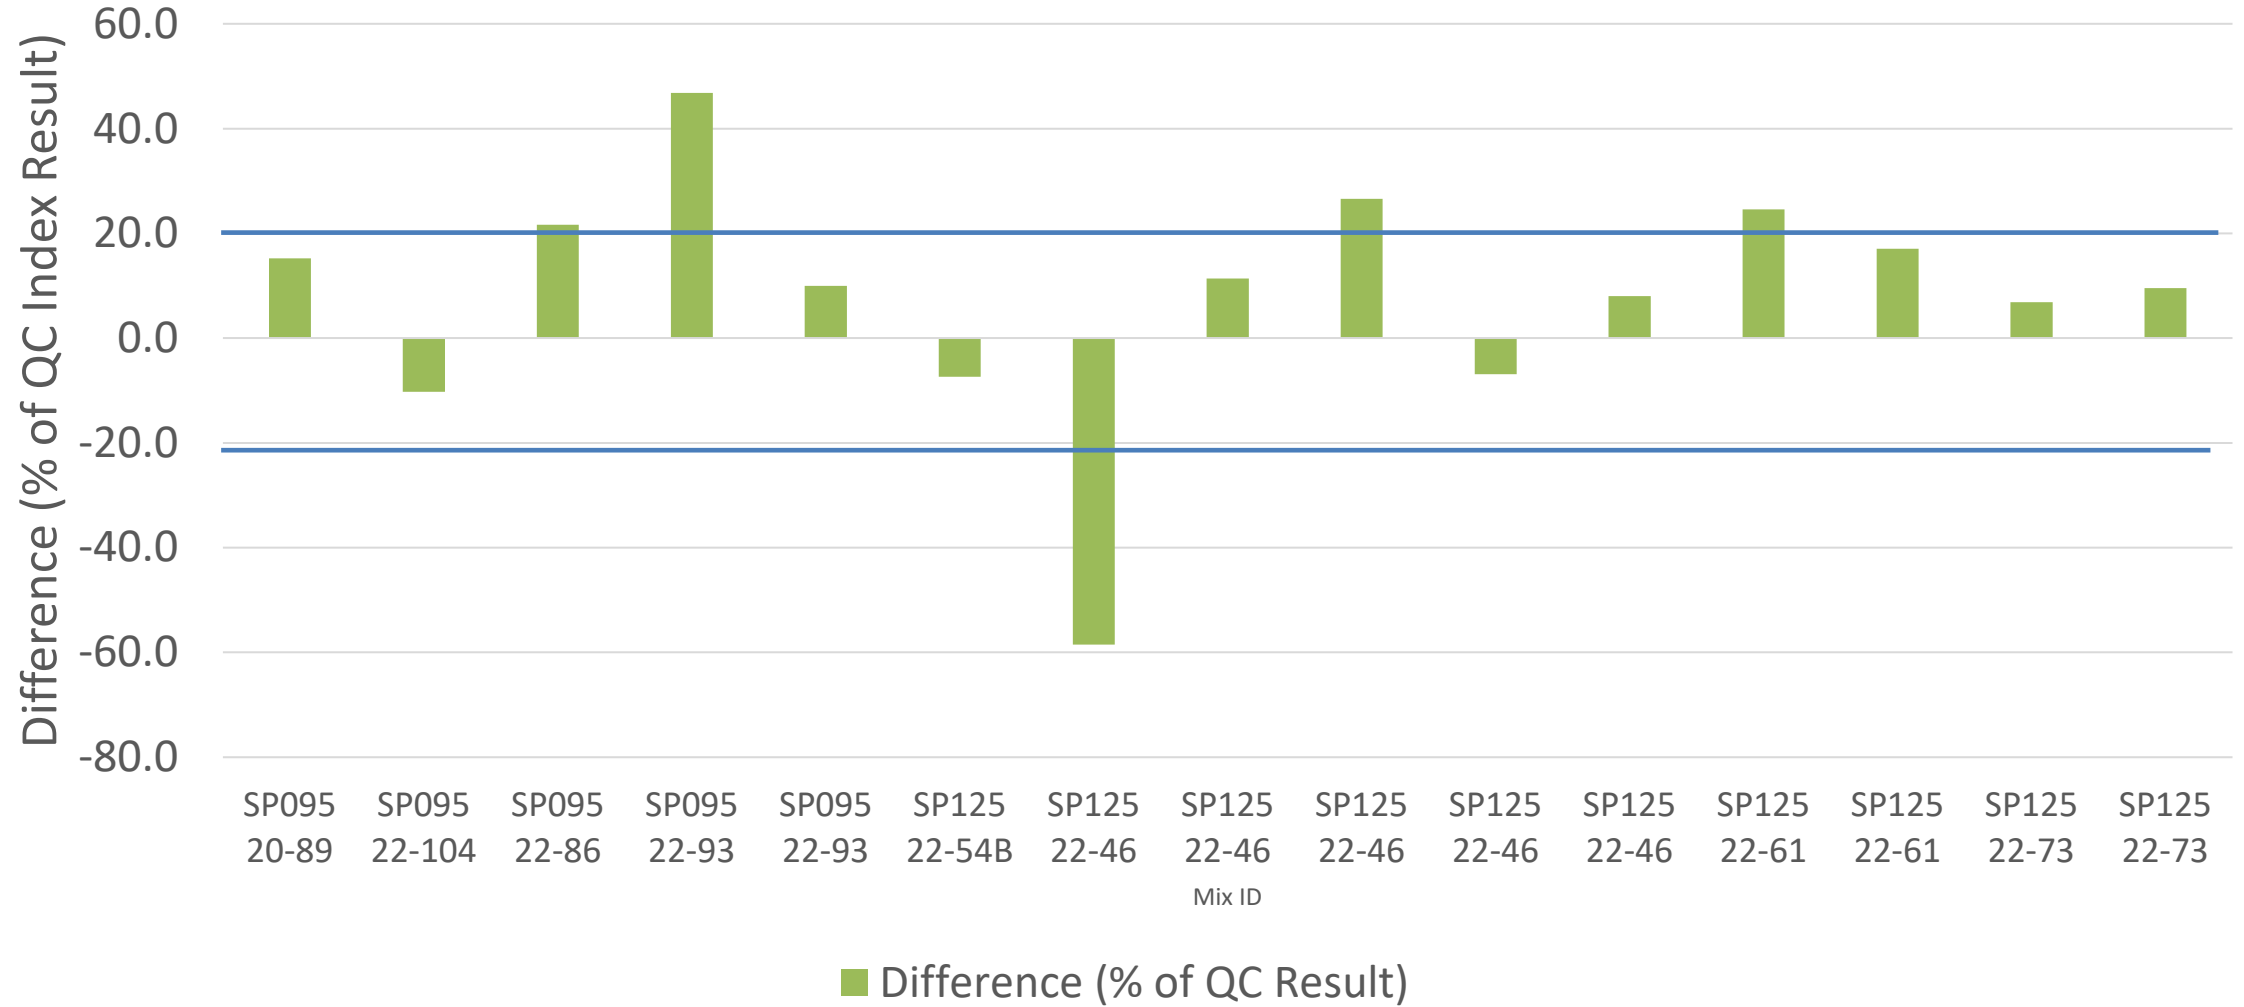
# QC vs. QA Individual Results Non-SMA Mixes

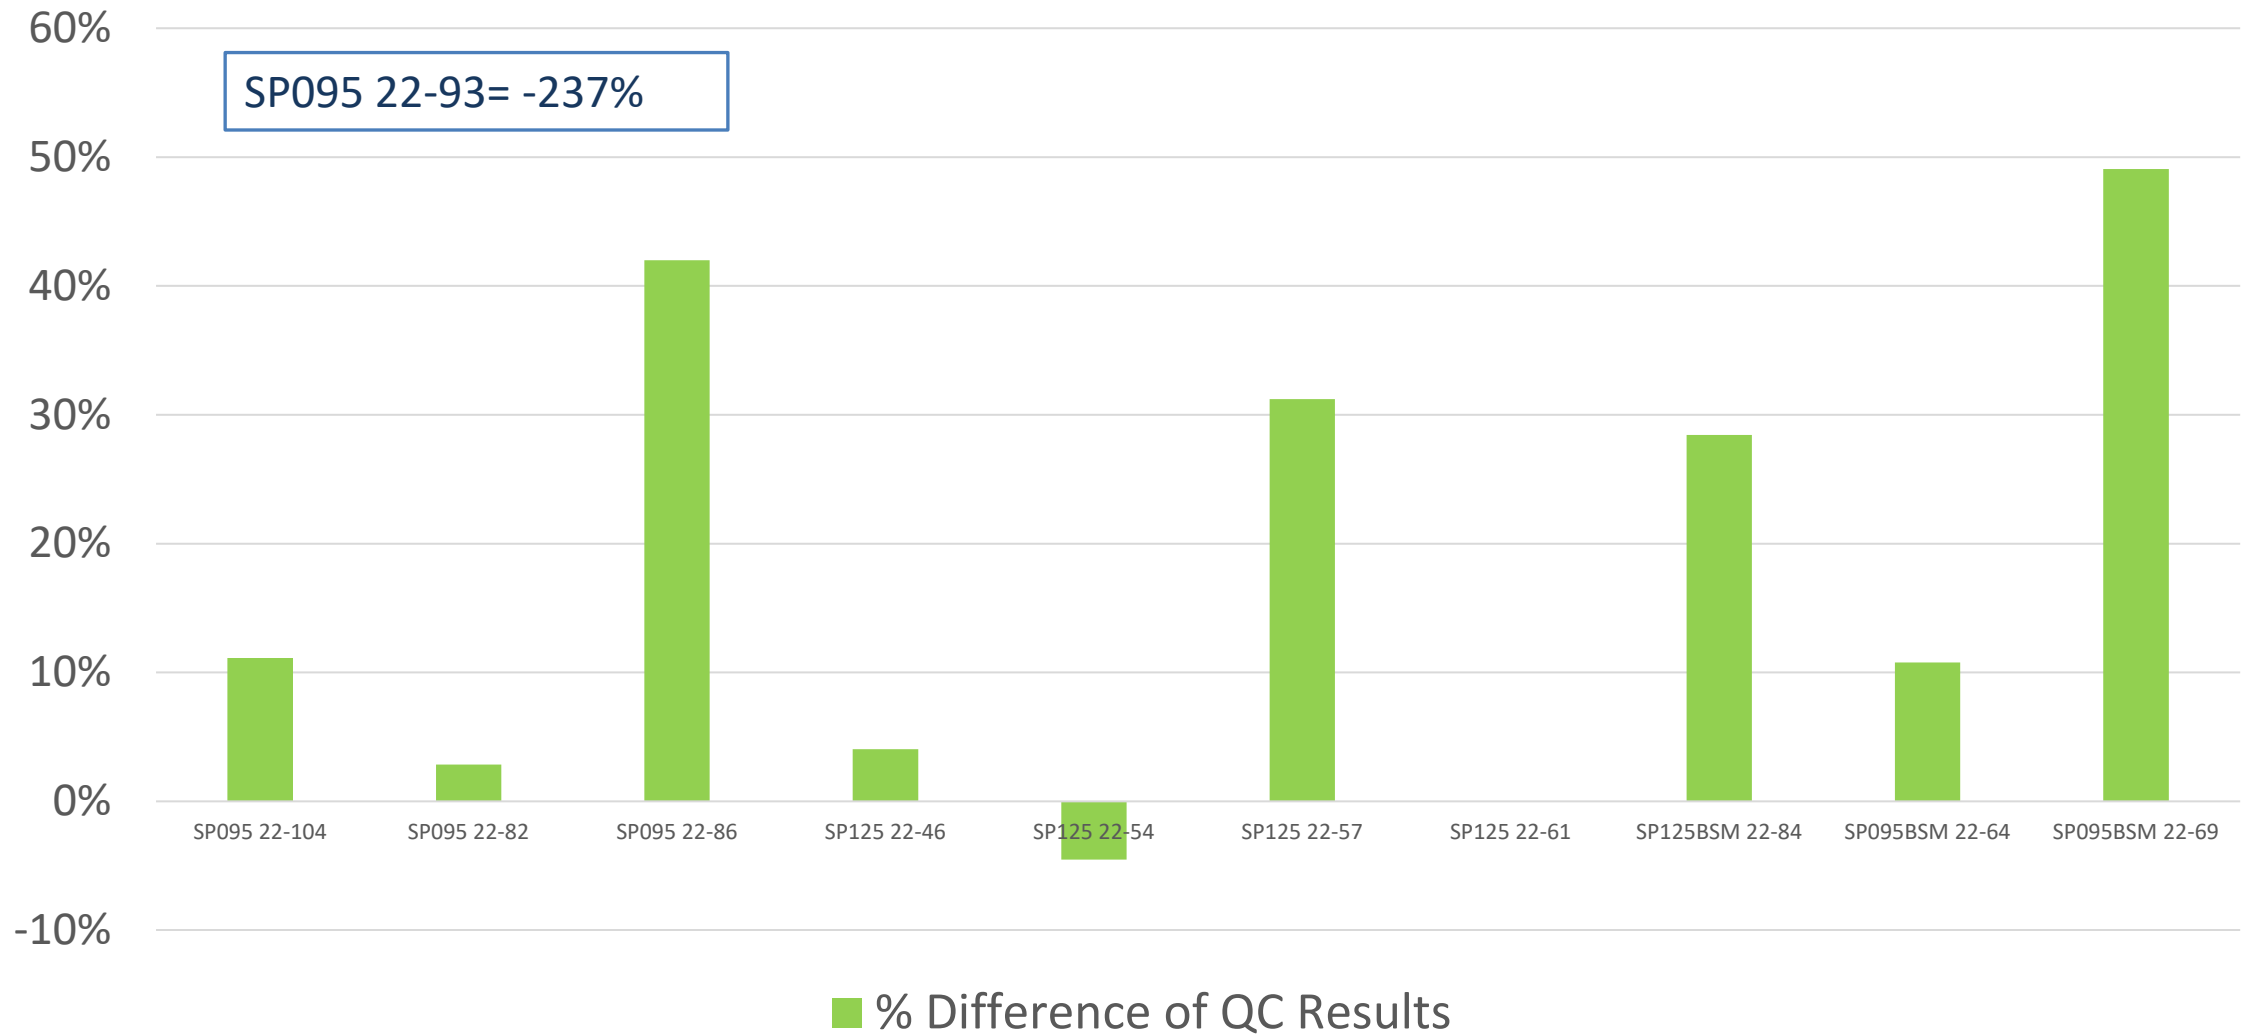
# CT<sub>Index</sub> - JMF vs QC Field Comparison

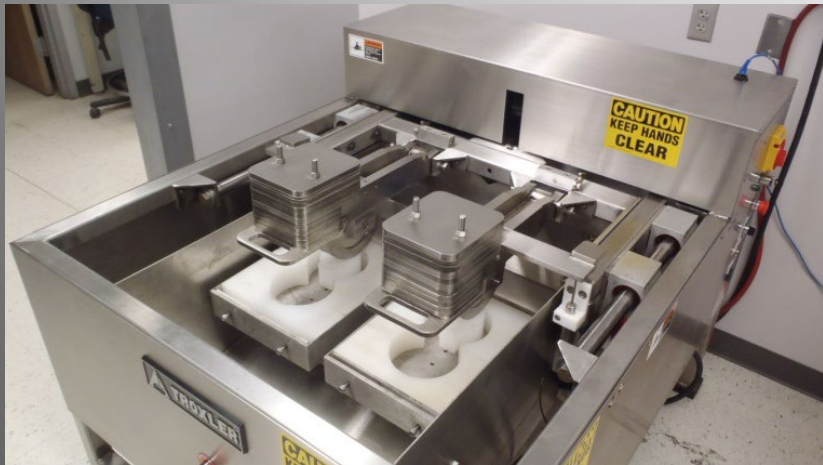
Hamburg Wheel

Track Test (HWTT)
